WATER QUALITY RESTORATION PLAN AND TOTAL MAXIMUM DAILY LOADS (TMDL) FOR THE BOBTAIL CREEK WATERSHED

Public Review Draft
November 2004

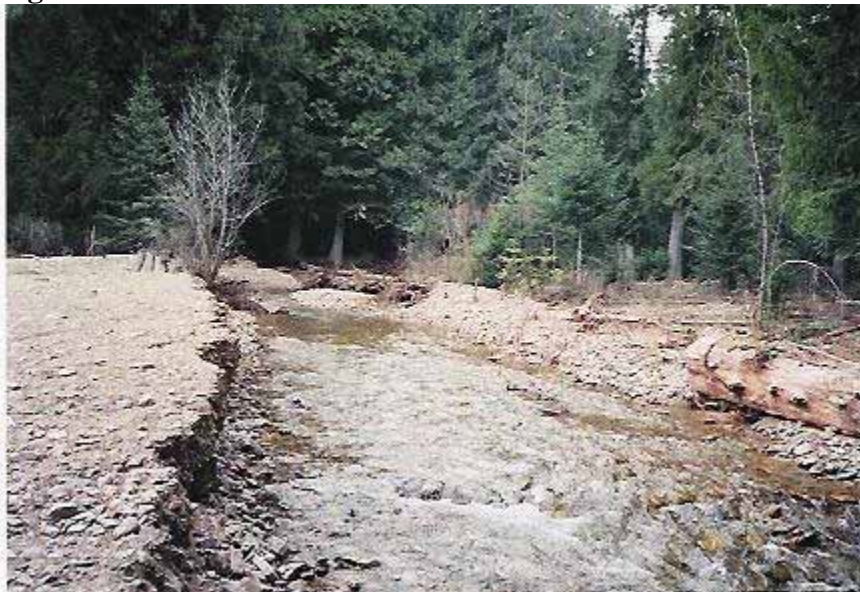
Figure 4-4. Area of Unstable Stream Reach.

In October 1999, the Bobtail Creek Watershed Group conducted field reviews of private holdings in unstable reaches in sections 29, 30, and 32 (T32N R31W) (Figure 2-4). Steve Wegner, a professional hydrologist with the USFS conducted these evaluations in conjunction with private property owners. These evaluations identified areas of eroding bank and channel instability in these reaches that contribute to sediment loading and reduced transport leading to siltation. Of considerable concern is a section where the stream left its historical channel and scoured an overflow channel 15 feet wide and 3 feet deep (Figure 4-4). This continues to act as a potential source of sediment loading to the stream. Other sources of sediment loading and habitat degradation from private land holdings include livestock grazing, private roads, and stream encroachment.
